# **Intel<sup>®</sup> Mobile Pentium<sup>®</sup> II Processor Specification Update**

Release Date: September 2000

Order Number: 243887-024

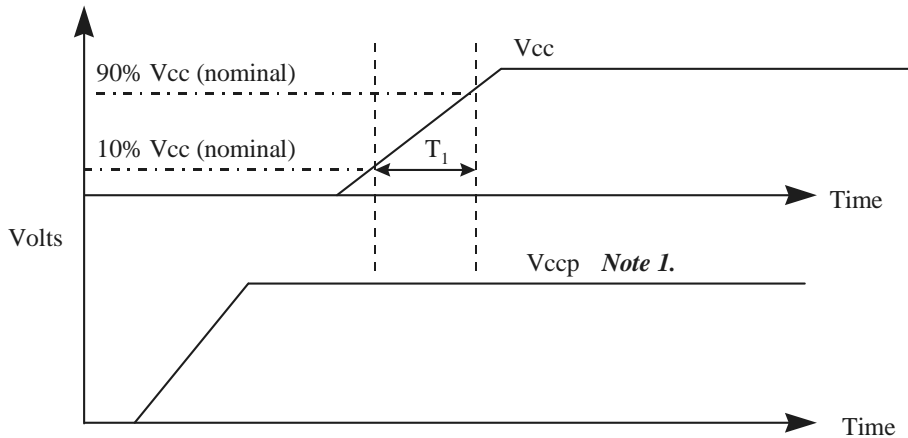
**Figure 1.  $V_{CC}/V_{CCP}$  Timing Requirements (Mobile)**

**Problem:** The processor uses the PWRGOOD signal to ensure that no voltage sequencing issues arise; no pin assertions should cause the processor to change its behavior until this signal is asserted, when all power supplies and clocks to the processor are valid and stable. However, if  $V_{CC}$  ramps up before  $V_{CCP}$ , it will cause the processor to enter an invalid state.

**Implication:** If this erratum occurs, the system may boot normally however, the L2 cache may not be initialized.

**Workaround:** For Mobile Pentium II processors, ensure that  $V_{CC}$  ramps after or with the L2 cache IO voltage ( $V_{CCP}$ ). If  $V_{CCP}$  ramps after the  $V_{CC}$ , a delay circuit can be placed on the core  $V_{CC}$  to ensure that  $V_{CC}$  ramps at the same time or after  $V_{CCP}$  as shown below in Figure 1.

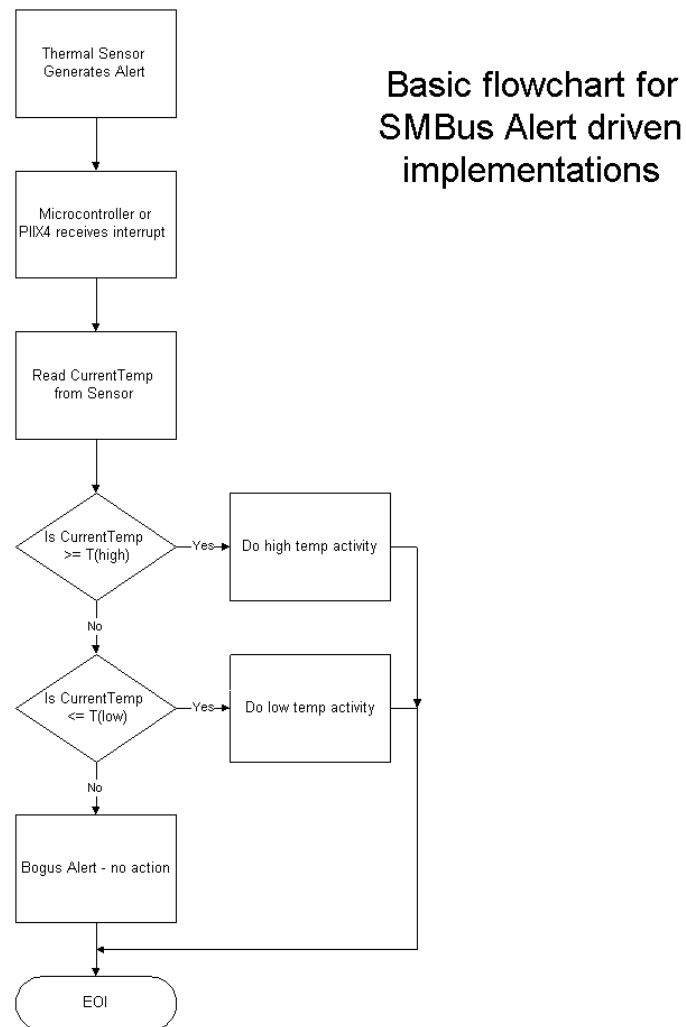
Figure 2. Workaround Flowchart: SMBALERT#-Driven System

**Problem:** The Mobile Pentium II processor and the Pentium II Processor Mobile Module have a thermal sensor that monitors the processor core's temperature. Please note that desktop systems could have a similar thermal device. The thermal sensor asserts SMBALERT# if the processor temperature exceeds the temperature limits set in the Alarm Threshold Registers ( $T_{HIGH}$ ,  $T_{LOW}$ ). It also sets the corresponding Status Register bits to identify the cause of the interrupt. Figure 1 gives one example of the how the SMBALERT# signal could be used in a system.

Under the conditions described below, the thermal sensor incorrectly generates the SMBALERT# interrupt. All of the following conditions must be met to trigger a false interrupt:

1. Before servicing an interrupt from the thermal sensor, read and compare the processor thermal reading with the threshold limits ( $T_{HIGH}$  or  $T_{LOW}$ ). Figures 2 and 3 provide basic flowcharts for the implementation of this workaround in an interrupt driven system.
2. If the firmware implemented polls the Status Register only, then before taking any action, re-read the temperature register and do a comparison with the alarm threshold limits ( $T_{HIGH}$  or  $T_{LOW}$ ) to determine if the value is actually still within the temperature window.

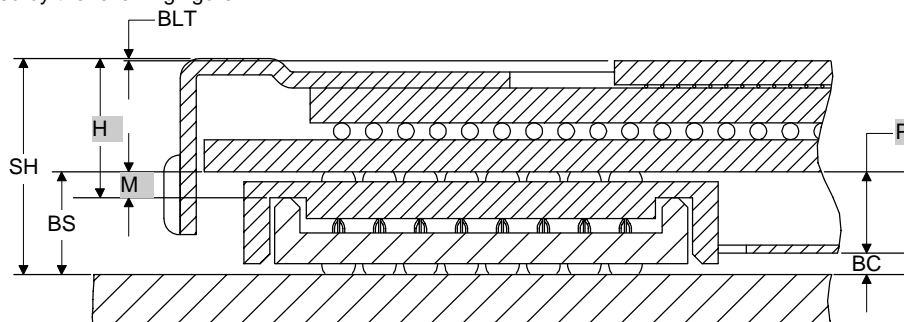
**Figure 5.6. Cross Sectional View with Vertical Dimensions**

### B1. Misabeled Vertical Dimension Parameters

Figure 5.6 in the *Mobile Pentium® II Processor at 233 MHz, 266 MHz, and 300 MHz* datasheet should be replaced by the following figure:

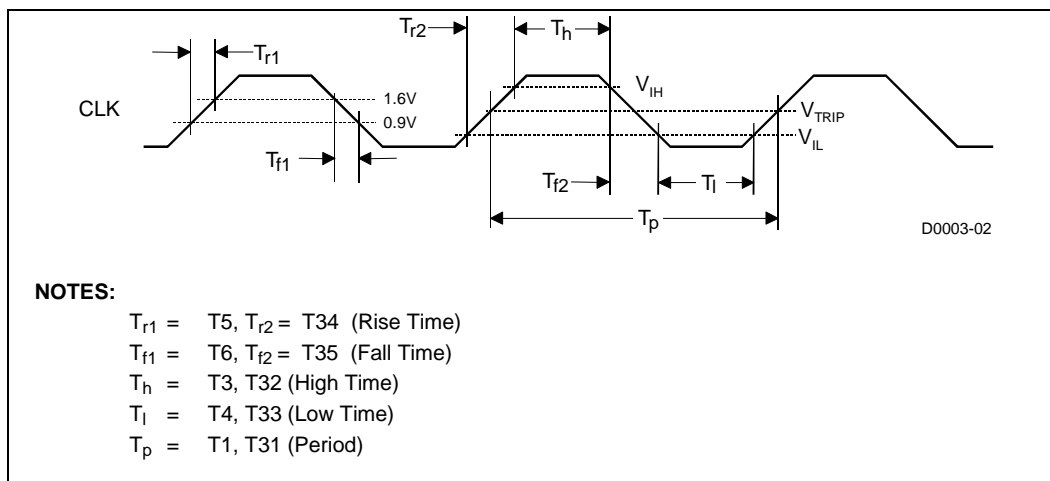
Figure 3.3 Generic Clock Waveform

Figure 3.3 in *Mobile Pentium® II Processor in Mini-Cartridge Package at 366 MHz, 333 MHz, 300PE MHz, and 266PE MHz* datasheet (Order Number 245108), and the *Mobile Pentium® II Processor in BGA Package at 366 MHz, 333 MHz, 300PE MHz, and 266PE MHz* datasheet (Order Number 245106) has been updated. The following figure is to replace the ones in the above documents.
